Case study 9:

site cleaned up after 4000 litre fuel leak

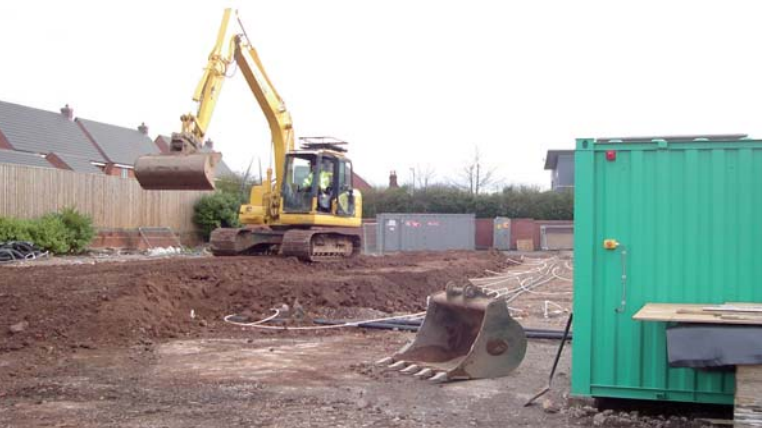
GRM's strategy incorporated in-situ bioremediation of contaminated soil and groundwater. This involved the installation of a grid of boreholes across the contaminated area. This network of boreholes was first utilised to remove free product, after which the Soil Vapour Extraction (SVE) & Air Sparging System was implemented. Being able to treat the soil and groundwater 'in-situ' saved the client considerable time and money, and enabled the project to proceed as quickly as possible.

Throughout the remedial works, GRM sampled and monitored groundwater quality on and off-site, to assess the progress. Within the first three months of the six-month treatment period, concentrations in a number of boreholes had been reduced to below laboratory detection levels.

After six months treatment it was established that off-site contamination had fallen to below detection levels, and on-site concentrations had stabilised. Hydrocarbon concentrations had reduced by an order of magnitude of 1000. GRM proceeded to implement a number of post-treatment measures to prevent any further migration and produced a completion report that detailed the success of the remedial scheme.
